OPERATION MILD WIND

SHOT PIN STRIPE

PROJECT OFFICERS REPORT—PROJECT 9.1

TECHNICAL DIRECTOR'S SUMMARY REPORT [redacted]

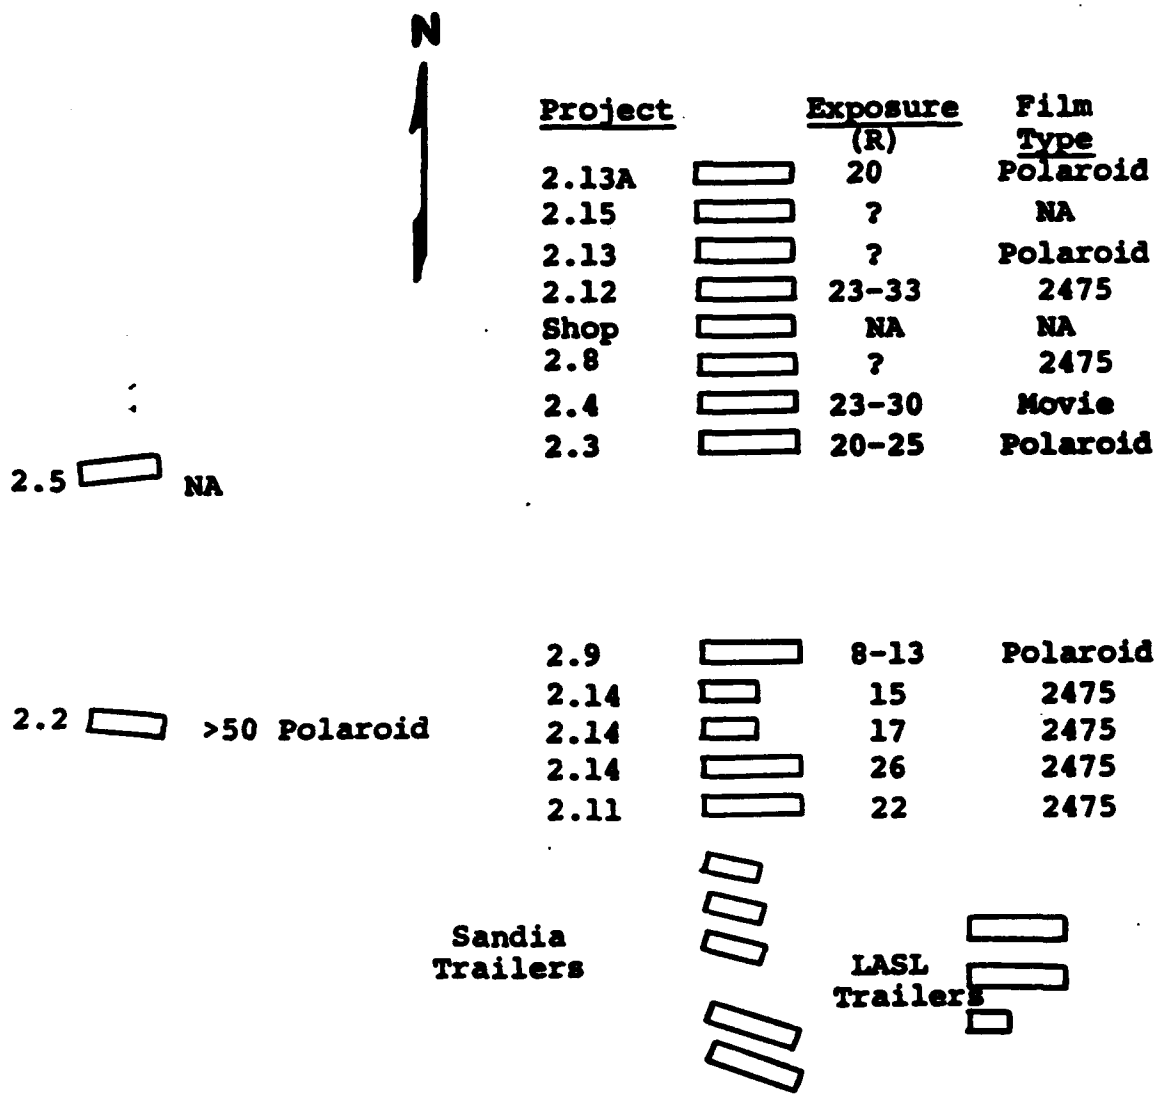
[redacted] The susceptibility of the film to fogging is a function of the oscilloscope sweep speed, the spot intensity, the ASA rating of the film, and the nature of the signal. One can conclude that the tolerance of typical traces on Polaroid 107 (ASA 3,000) is about 10 R when sweep speeds of about 0.1 μ sec/cm are used. Film of 10,000 speed should be avoided, and the practice of making the trace very thin should be abandoned for field tests. The signal should be burned in for maximum contrast. Obviously, no data was obtained from the close-in, Project 2.2, trailer due to the very high radiation exposure at that location.

Figure F.1 [redacted] Radiation exposures in trailers.
